## VICKERS 610 VIKING 1B G-AIVG

### PETER F PEYER details the meticulous work undertaken by a small group of enthusiasts at Basel to restore a former BEA Viking to static display condition

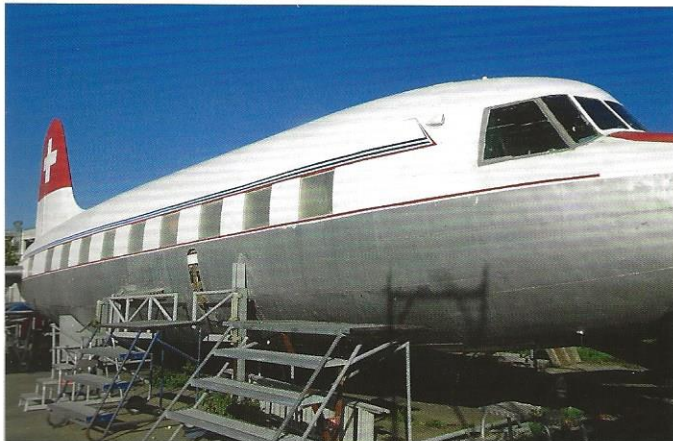
*Recent progress with the restoration of the former BEA Viking has been excellent, and here the aircraft is seen on October 13 2018 following the application of basic Balair livery, although the aircraft never flew for the famous Swiss charter company.*

- Refurbishment of the two-tone cheat line below the windows
- Placement of ADF loop-antennae housings on top of fuselage
- Reconstruction of window frames lost after dismantling of the original windows for cleaning.
- Complete revision of main passenger door including locking system
- Application of registration HB-AAR
- Cleaning and painting the propellers
- Completion of sheet metal repair to underside of fuselage

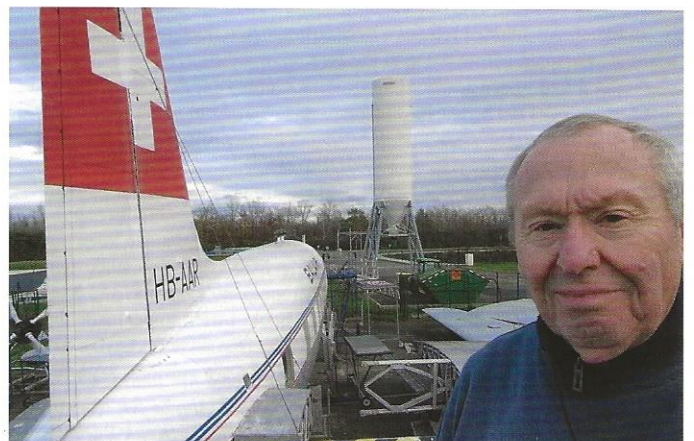
*Recent view of the restoration scene as the Viking continues to take shape in the hands of a dedicated group of enthusiasts led by Balz Buser (president) and Wolfgang Neumann (chief engineer), and including Christian Hartmann, Dieter Buser, Roger Frossard and Walter Schweizer.*

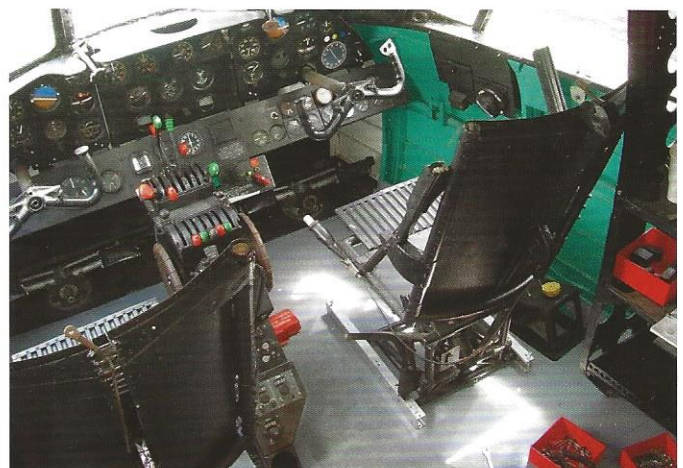
*Wolfgang Neumann's hard work has recreated the cockpit of the Viking to include much of the early style equipment.*

One remarkable task undertaken by Wolfgang Neumann during a winter was the restoration of the cockpit to near original state by cleaning and reassembling all the vital instruments, while also refurbishing the pilots' seats and even the swivel chair of the radio operator. The ADF antennae, complete with their familiar stream-lined housings, have also been put back in place.
